Principal	Lilkenya Jenkins
Grades	1-5
Staff	38
Current Enrollment	326
Site Size	9 Acres
Square Footage	65,100
Year Constructed	1947, 1954, 1956, 1962
Renovations	Various, 2007

Thornwell School for the Arts

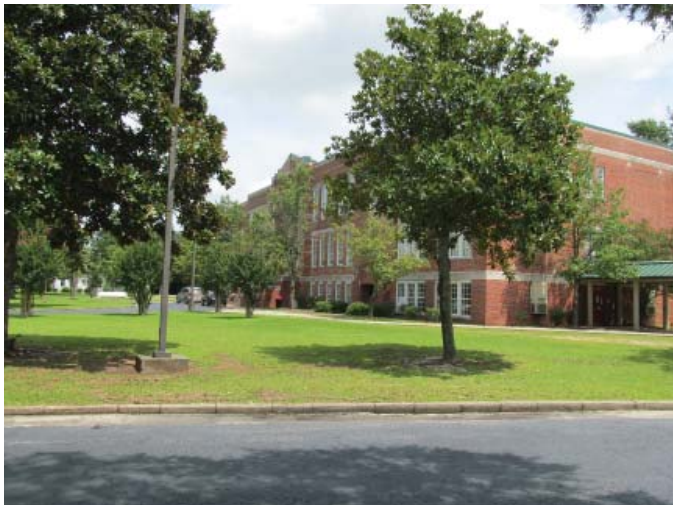
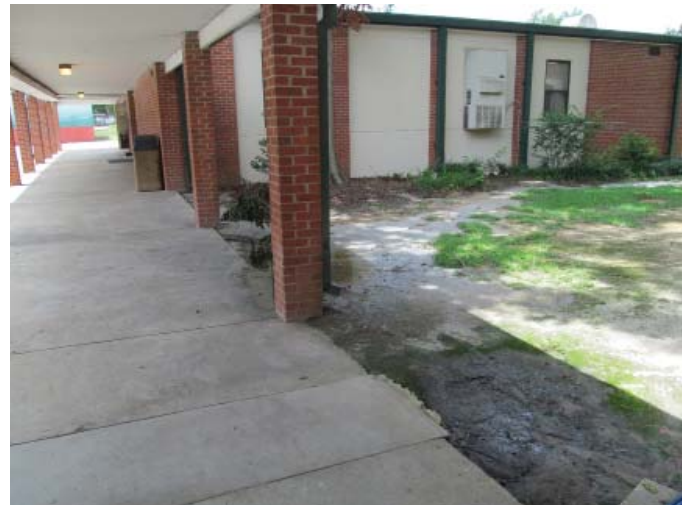
- Parking areas need improved circulation and efficiency as well as signage
- Ramps at some doors are not ADA accessible

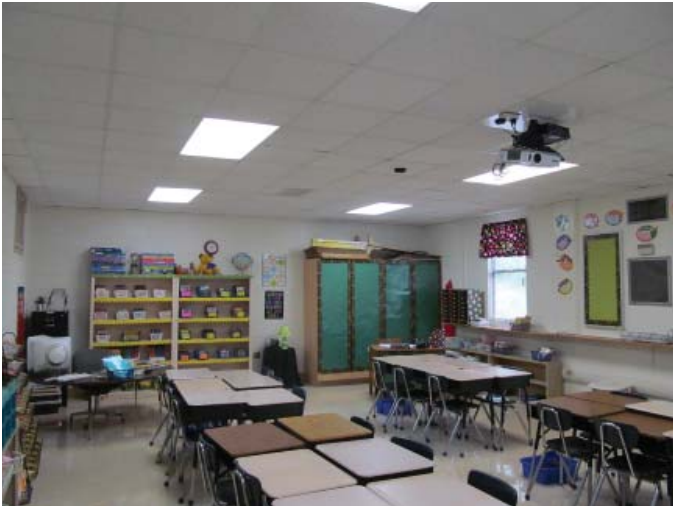
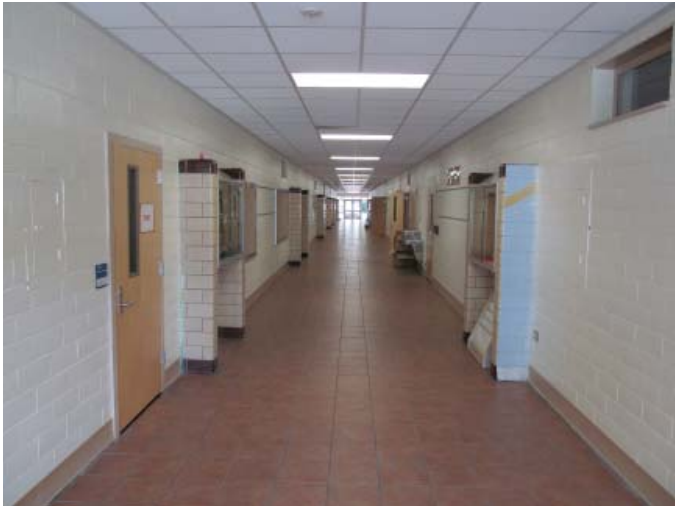
- Exterior doors have hardware and ADA issues
- Brick needs to be tuck-pointed
- Windows in media and cafeteria need to be addressed

- Some interior doors need to address ADA clearances
- Restrooms and fixtures do not meet ADA standards

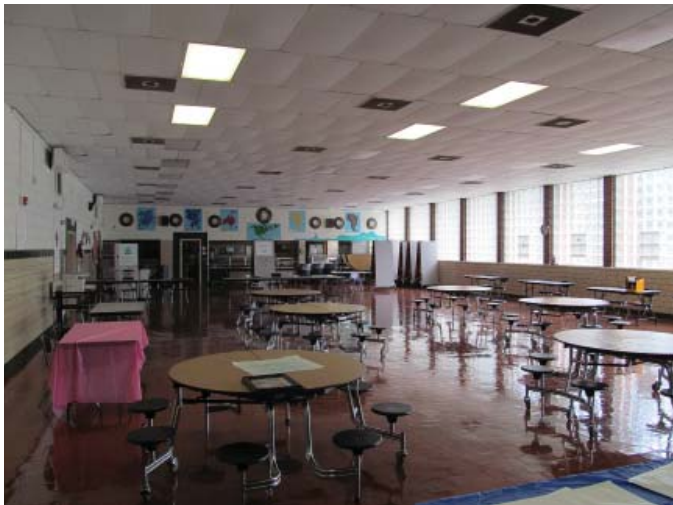
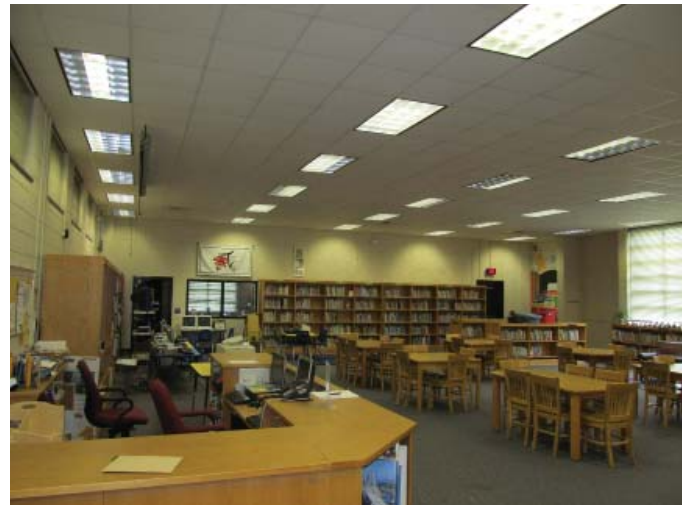
- Offices and waiting area are small
- Additional conference spaces are recommended
- Kitchen needs walls patched where windows once were located
- Music room remoteness is a security concern
- Lower bookshelves recommended in media center for age group
- Art room would benefit from more natural light and access to outdoor space
- Gym and support spaces need renovations
