Principal	Emily Lunn
Grades	4K-2
Staff	62
Current Enrollment	393
Site Size	22 Acres
Square Footage	45,876
Year Constructed	1956, 1980, 1989
Renovations	-

Pate Elementary School

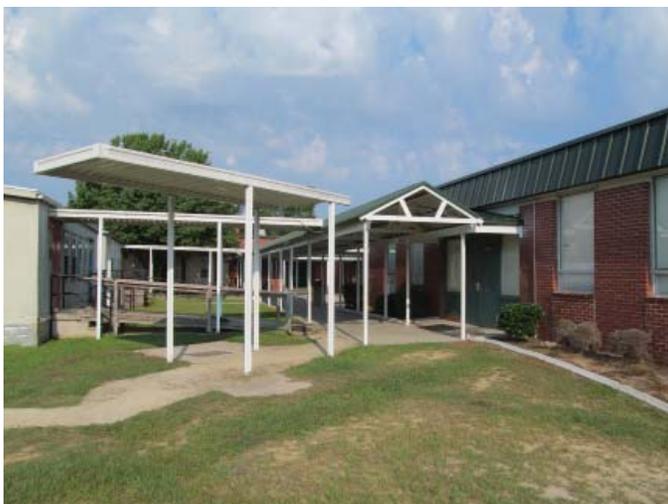
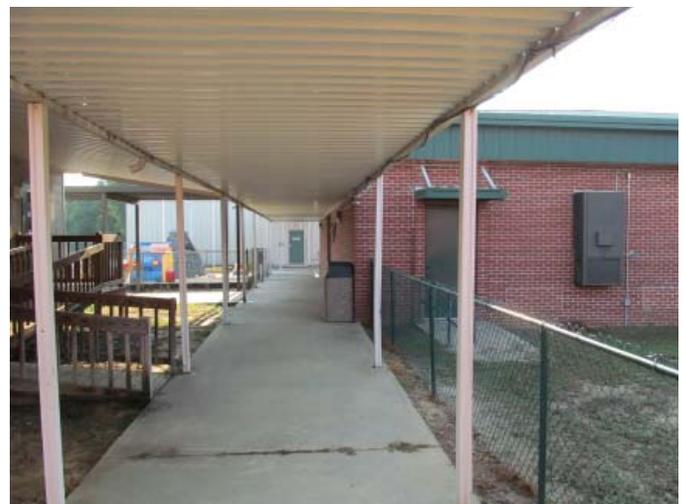
- Traffic patterns are awkward for parent drop off
- Drainage issue around media center building
- Continuity of covered walk from bus drop off recommended

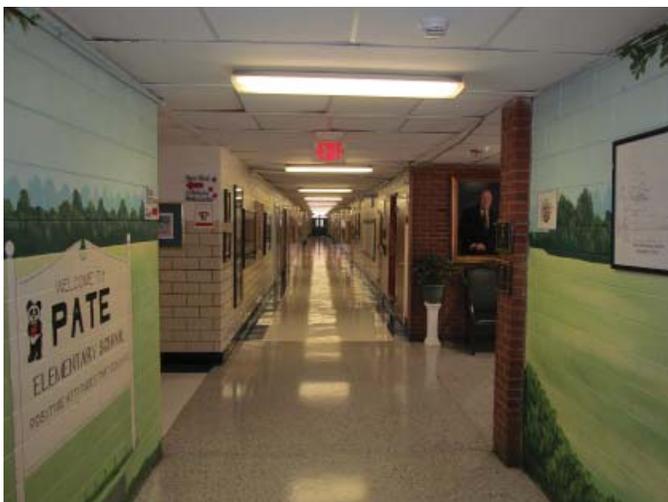
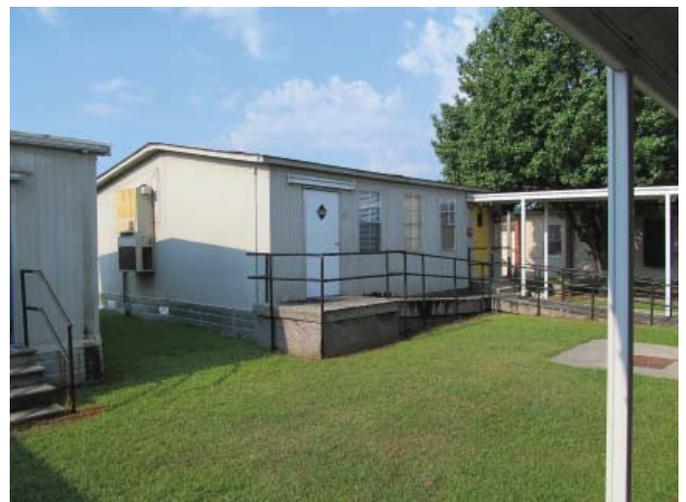
- Media center exterior door needs proper hardware
- Some exterior doors need to address hardware and ADA issues
- Windows not energy efficient

- Interior doors need new hardware in some spaces
- Several restrooms need new fixtures or do not meet ADA

Building 1: A major renovations to electrical systems to include addition of outlets throughout the classrooms areas should occur. Renovation should also include toilet areas to insure that some ADA compliant fixtures are included. A new MDF room should be created to house computer systems. An interior corridor could be created and a two classroom addition constructed adjacent to media center where two portables are currently housed. This addition would house the students currently served by the two portables. The bus loop would need to be re-configured if the district wishes to maximize addition to include two more rooms.

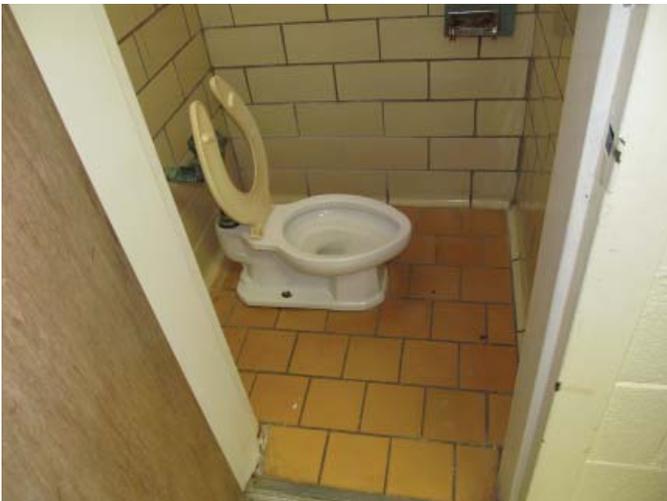
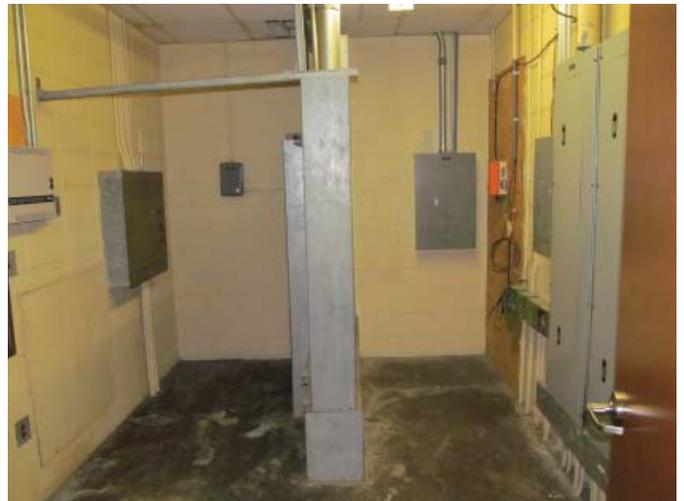
- PE lacks air quality creating a smell and moisture issues

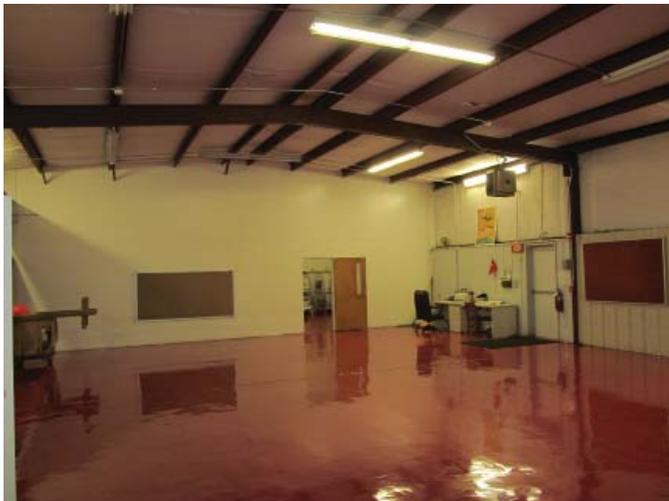
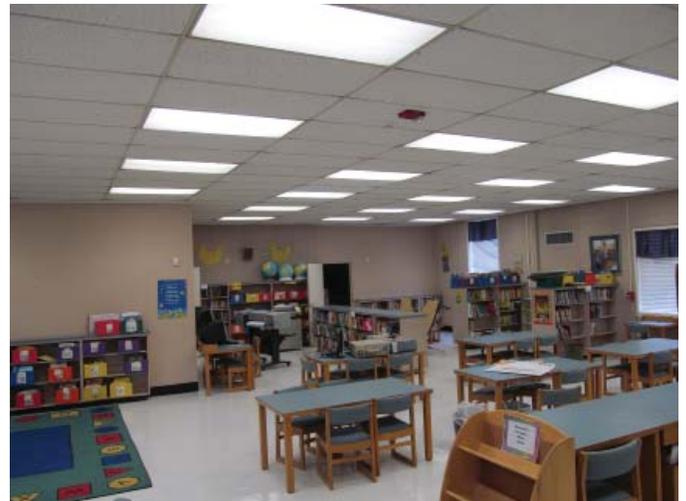
- Main office does not have visual connection to school entry
- Offices and waiting area are cramped
- All classrooms are in need of updated finishes
- No stage/platform on campus
- Crack in multipurpose concrete slab has telegraphed to floor finish
- Music room could use additional acoustical treatment
- Art room lacks natural light and needs additional sinks

Building 2: It is the opinion of the architect that the existing multi-purpose building is torn down and that a new multipurpose building be built to include a stage, this could occur directly off the back of the cafeteria building. If district wishes new classrooms could be constructed as part of this addition for future growth.

Building 3: A two classroom addition, where the 4k play area and portables are currently located could house a new art room with kiln and a new music room. This addition could also connect adjacent to existing classroom 7, creating support areas for the kindergarten fine arts building. The two rooms where Music and Art were once located could house two 5k rooms currently located in the cafeteria area.
